FLUIDICALLY CONTROLLED CARGO HOOK
Walter Huebner, et al
United Aircraft Corporation

Army Air Mobility Research and Development Laboratory

March 1975

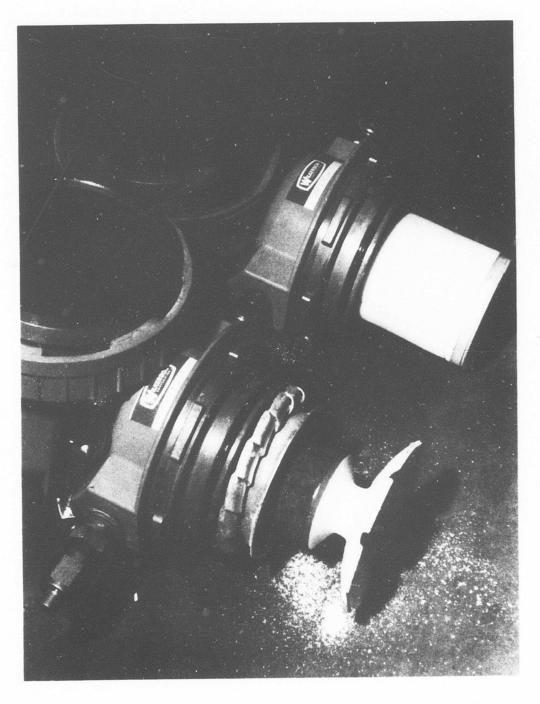
Soon after the system was turned on, a functional check was performed. The hook released properly, but the interface valve did not return completely to the off mode. That is, the interface valve began to bypass

Figure 20. Condition of System Filters After Contaminated Air Test.

flow from the supply port to the exhaust port. Functional tests were performed every 10 minutes thereafter. During the second functional check, the fluidic supply pressure was noted to be 7.5 psig. During the seventh functional check, the fluidic supply pressure had decreased to 6.5 psig. During the ninth functional check, the interface valve internal leakage ceased. At the completion of the test, the system was inspected for evidence of contamination. A heavy quantity of sand was found inside the interface valve body and on its poppets. Large quantities of sand were found in the regulator. Figure 21 shows the sand accumulation. No evidence of contamination was found in the fluidic controls module. Traces of sand and water were found in the hoist slip ring. No evidence of contamination was found in the hook slip ring or hook actuator.

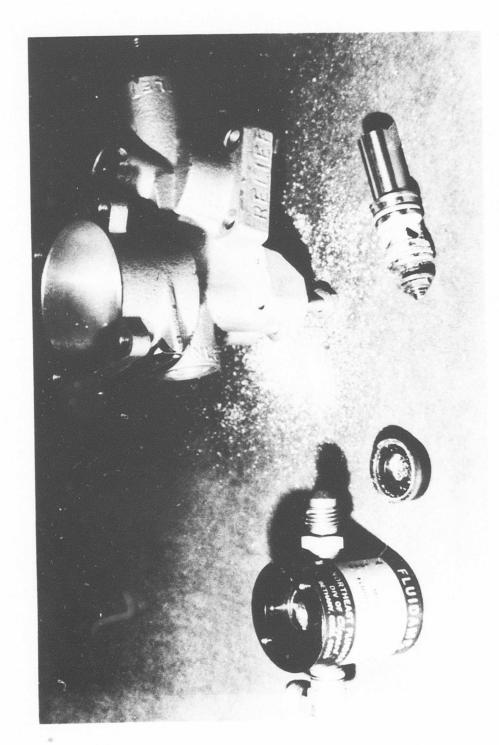
Figure 21. Sand Accumulation in Pressure Regulator and Interface Valve.

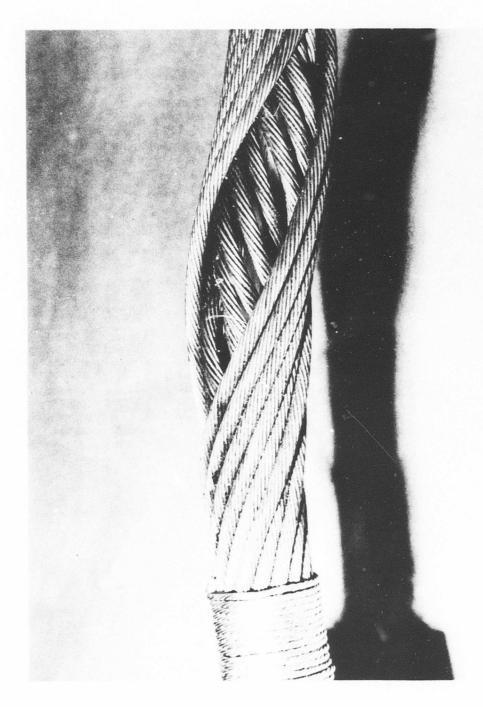
Figure 29. Displacement of Strands on Cable Assembly.

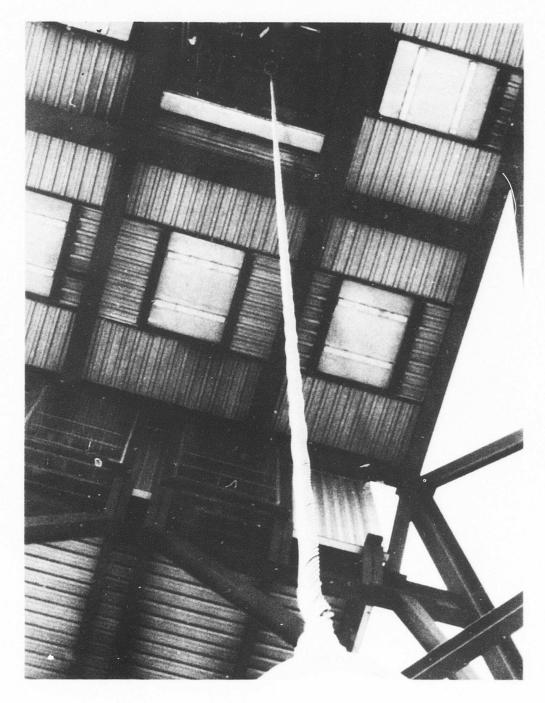
Figure 30. Waves on Cable Assembly.

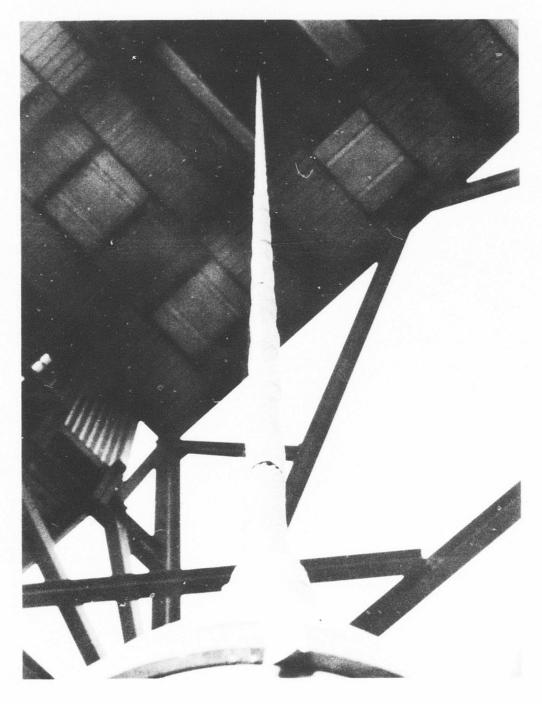
Figure 31. Installation of Repaired Cable.

The repaired cable was installed in the test facility. The repairs consisted of cutting off about 10 feet of the damaged end of the cable and replacing the swaged end fitting. In addition, the outside diameter of the cable was whipped with wire for a length of about 6 feet above the end fitting. The installed cable is shown in Figure 31. A functional check of the system demonstrated operation to be normal. Both hook condition indicators were operable, but required bleed flow to eliminate flickering.

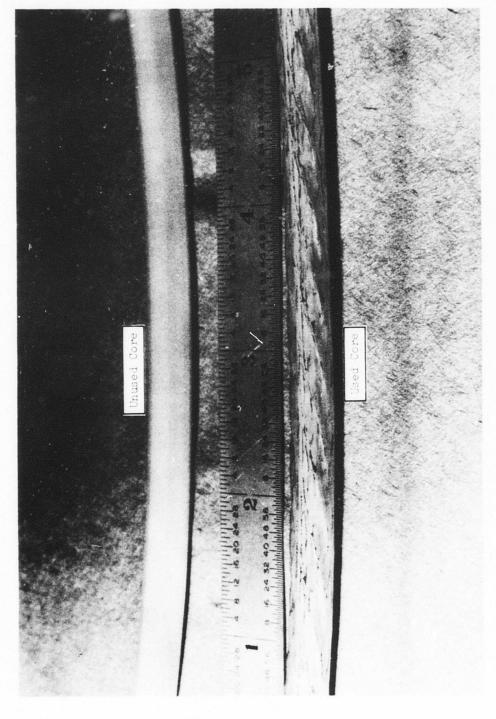
Figure 33. Pattern of Deformation at Cable Core.

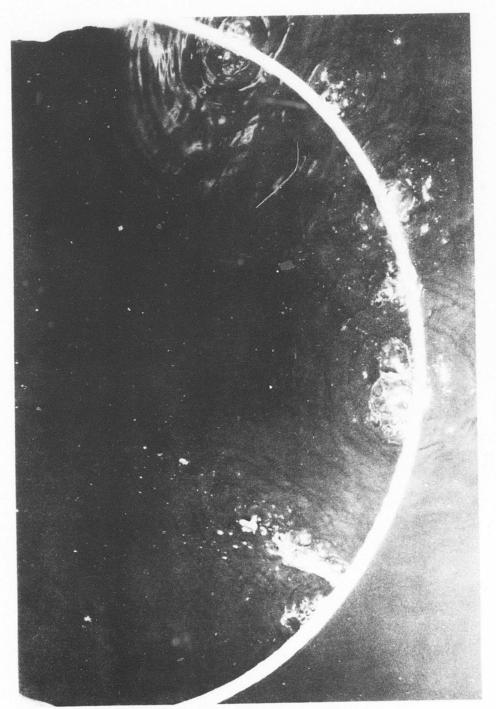
Figure 34. Core Leakage.

Cable core damage ultimately resulted in loss of remote release capability. Before this occurred, core damage in the form of increased restriction was evidenced first by faulty operation of the hook loaded and then the hook closed indicators. Blocked line pressures were unchanged, but unblocked levels had increased. It was demonstrated that correct indicator operation resumed after incorporation of a bleed flow to atmosphere through a tee fitting installed in each sensor line behind the control module. This technique is illustrated in Figure 37.

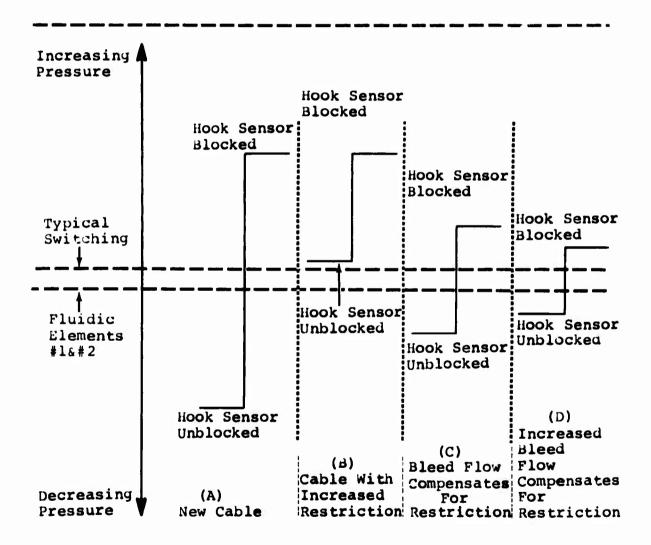
Figure 37. Technique Used in Restoring Indicator Operation.

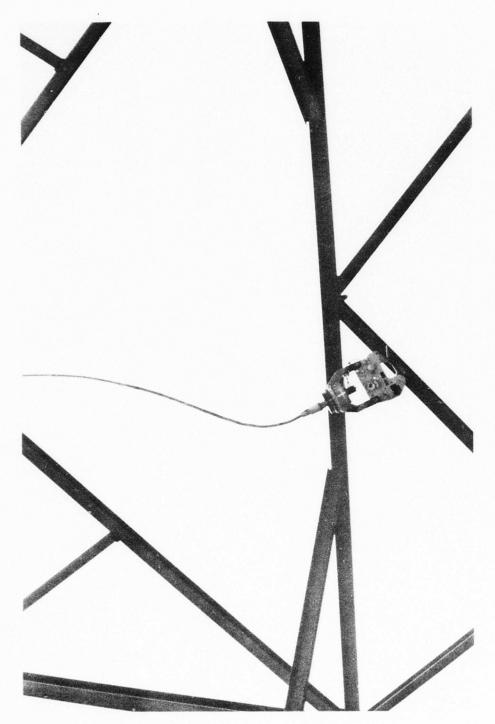
Observation of system operation indicated that the life of the cable core was greatly affected by the number of heavy load airdrops performed. The core damage incurred during testing, specifically the leakage found in the last 2 feet of conductor, was directly related to violent bending of

Figure 38. Cable Reaction to Airdrop.

the cable in this area. Immediately following a typical heavy load airdrop, the following sequence occurs: The hook travels straight up, turning over and curling the cable behind it, for a distance of approximately 30 feet. Figure 38 shows the hook starting this upward excursion immediately after the load was released. The hook then plummets straight down, in the inverted position, until the end of the cable is reached. It then, violently, snaps around through the upright position, to the inverted position again. This action continues for several cycles with diminishing amplitude. At least three must be considered severe. Other operations performed during hoisting do not abuse this area of the cable. Normally, this section never even wraps on the drum.
